# Bridge Inspection

Exploring the Bridge Inspection Process from Deck to Foundation

ASHE Harrisburg Back-to-Basics Lunch & Learn

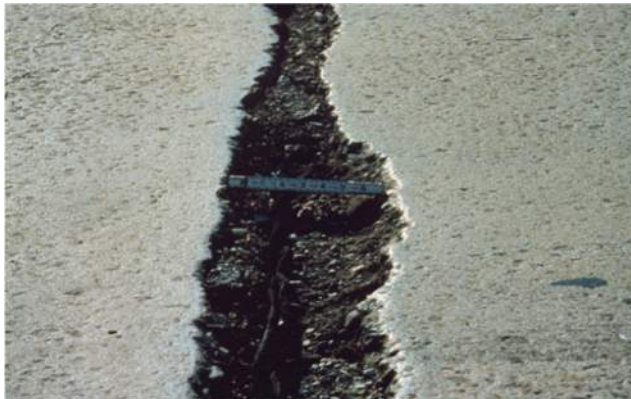
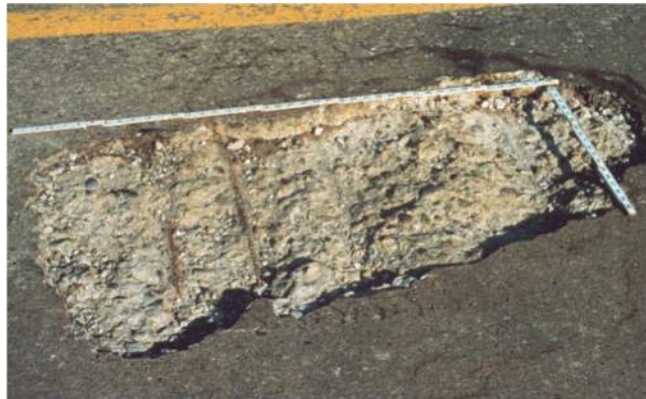
Some Moderate Defects

Deck Component  
Condition Rating:  
“5 – Fair”

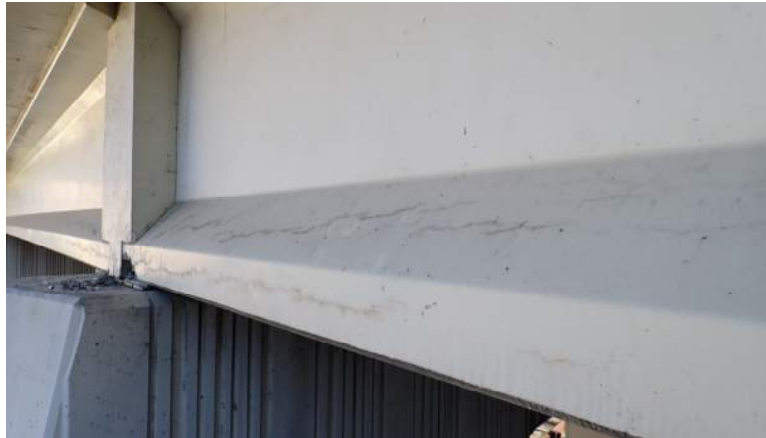
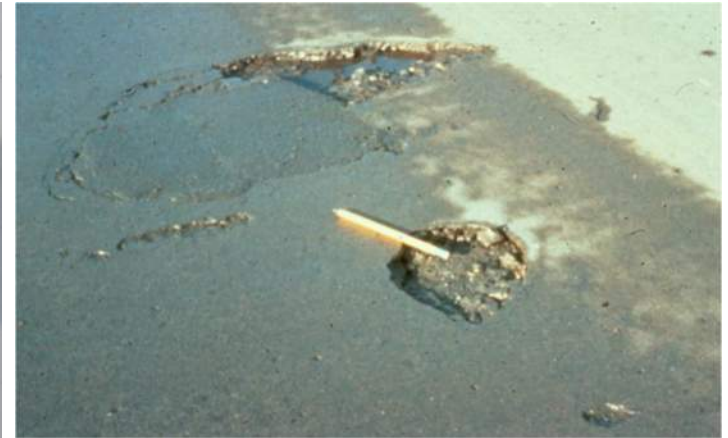
- Concrete

- Cracking
- Delamination
- Spalling
- Exposed Rebar

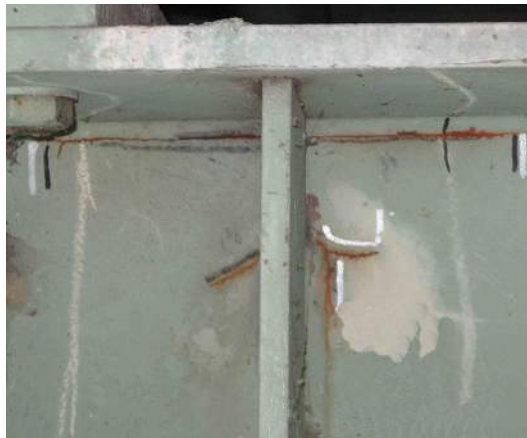
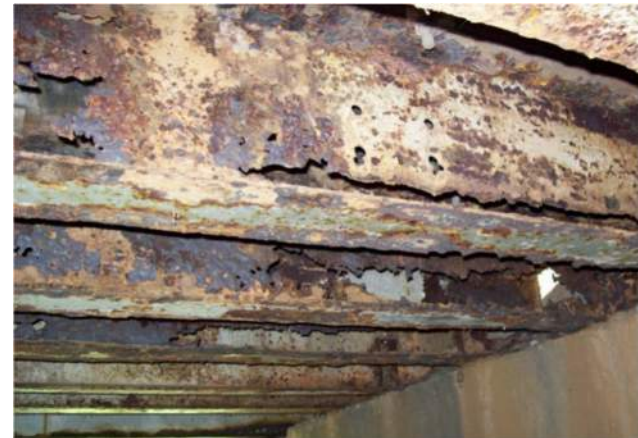
- Steel

- Corrosion/Pack Rust
- Section Loss
- Fatigue Cracks

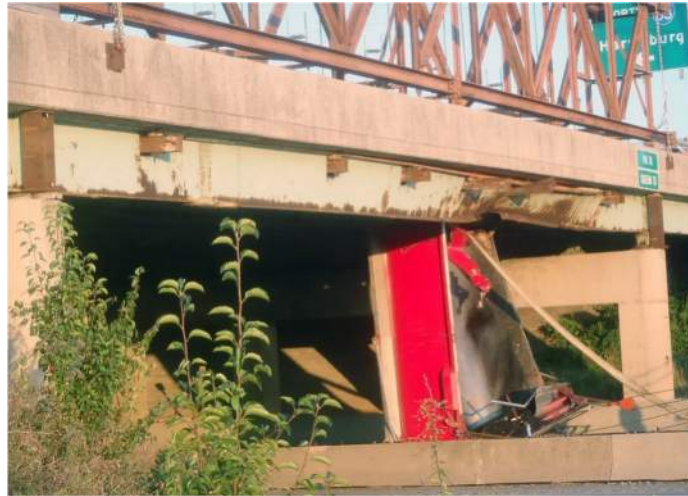
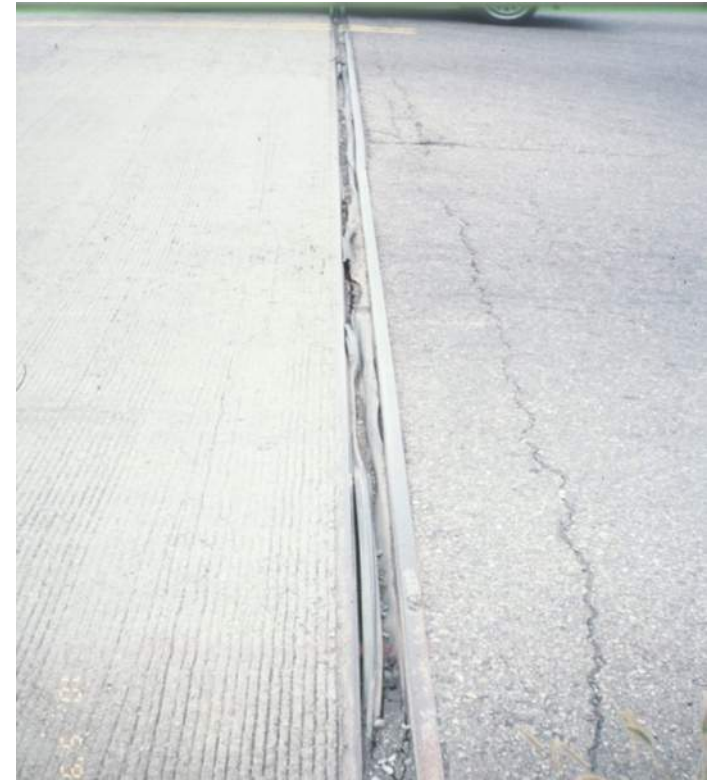
- Leaking Joints
- Movement / Settlement
- Collision Damage
- Flood Debris

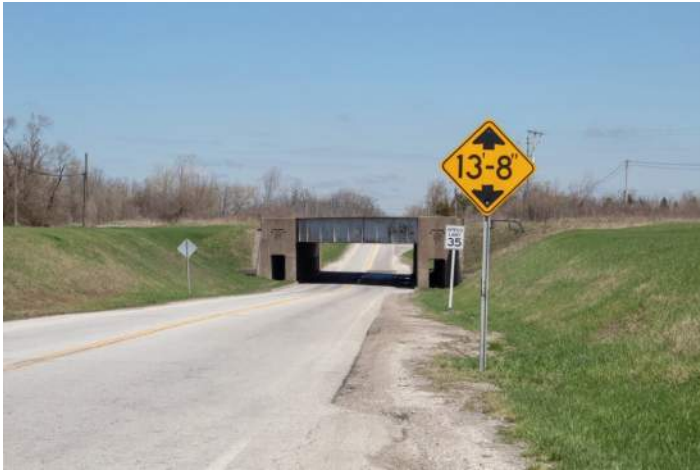
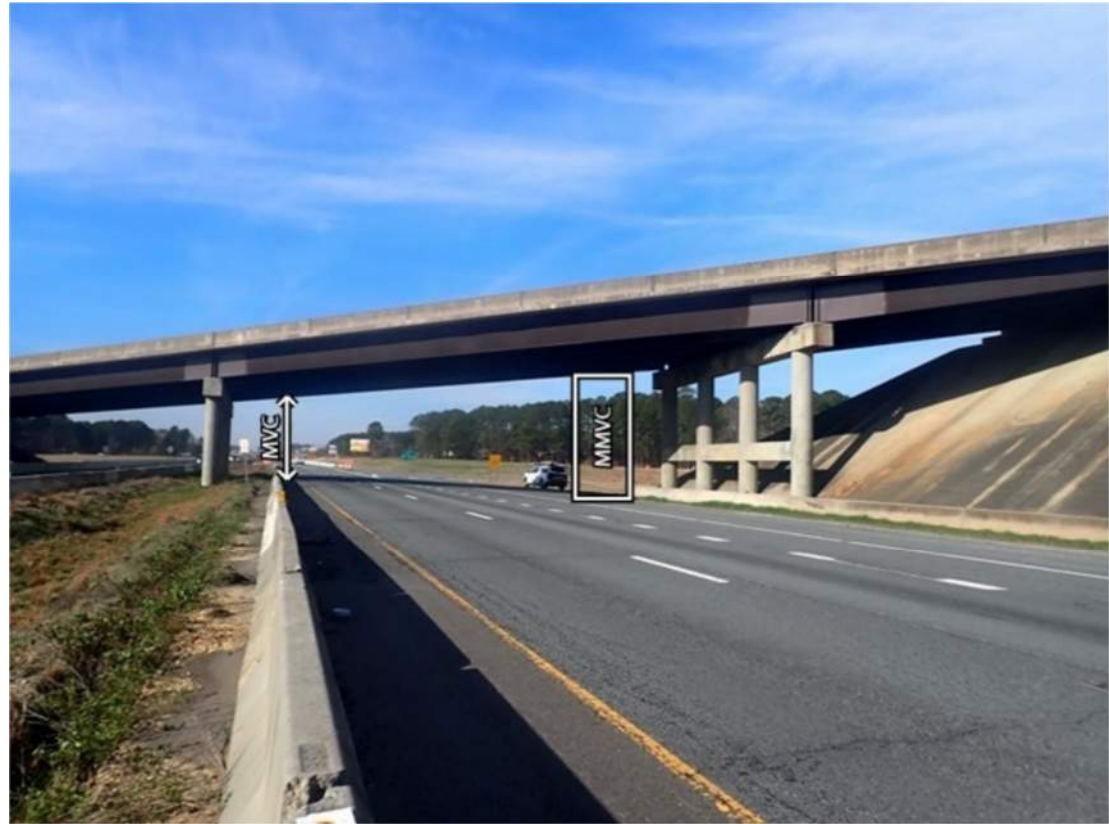
- Vertical Clearances
- Horizontal Clearances
- Waterway Features

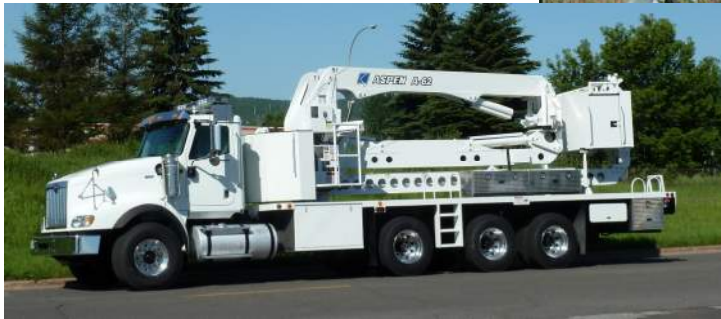
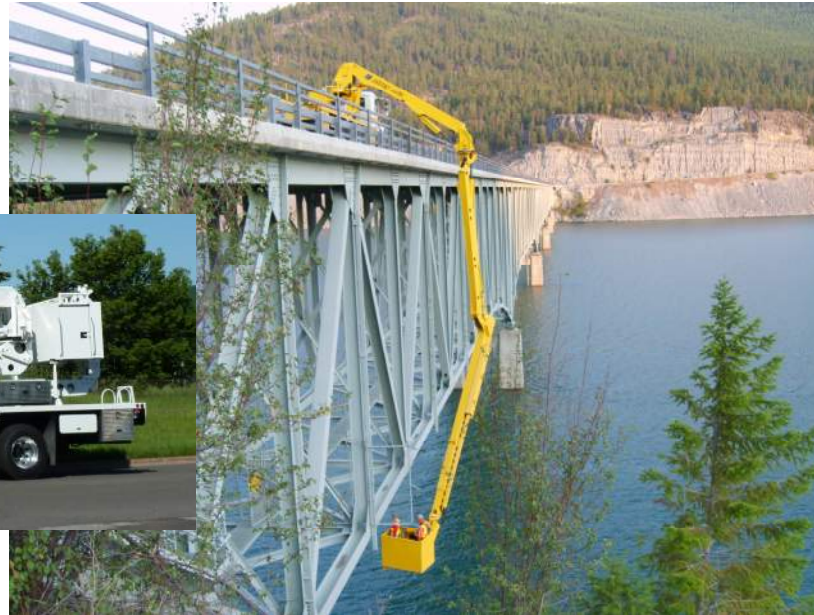
- Underbridge Inspection (UBI) Unit – “Snooper”

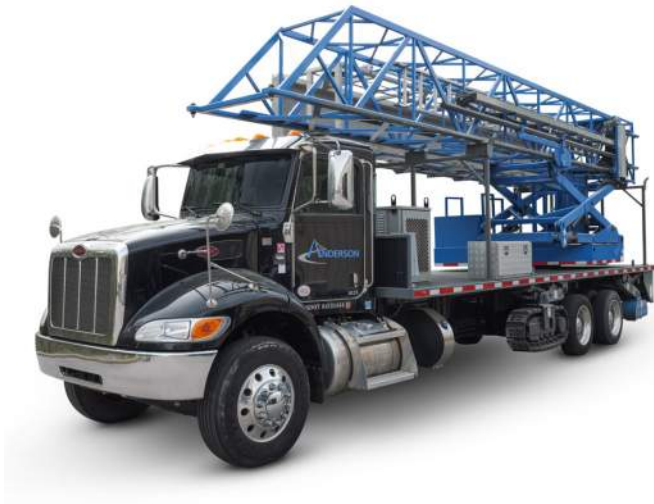
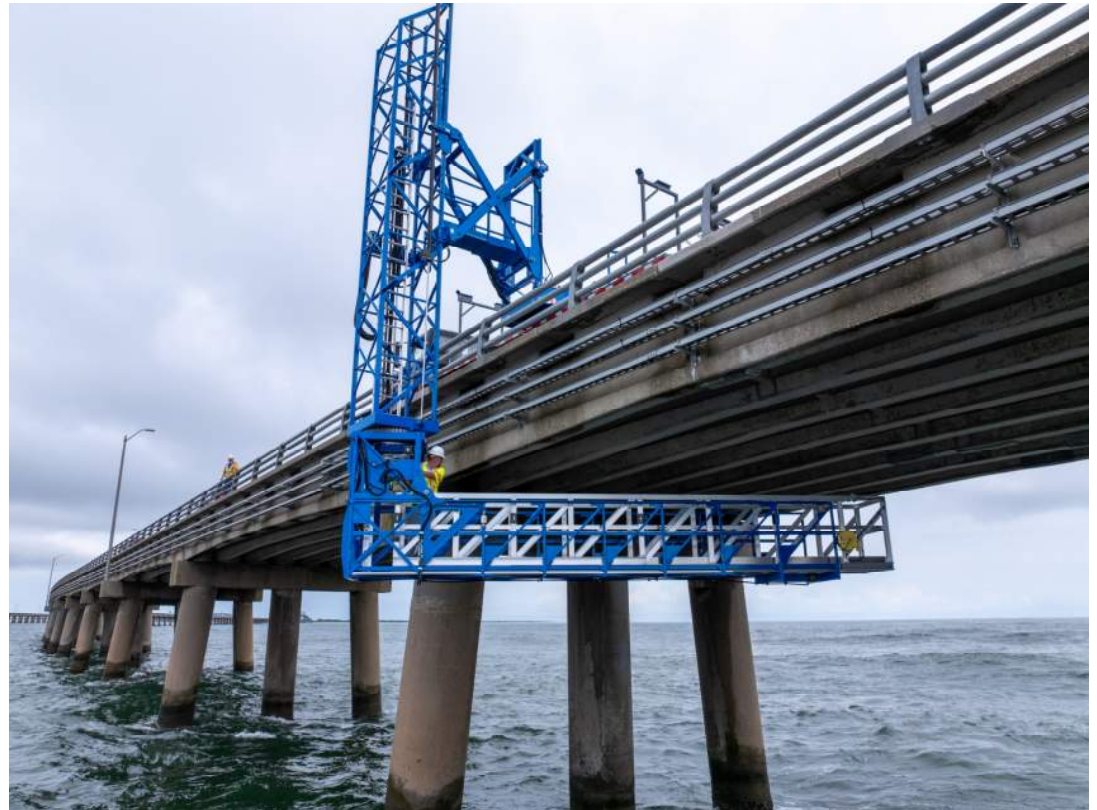
- Underbridge Platforms

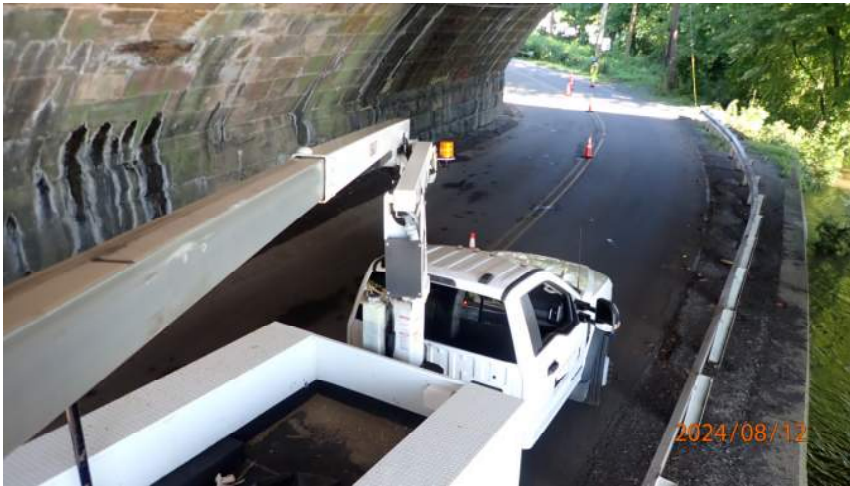
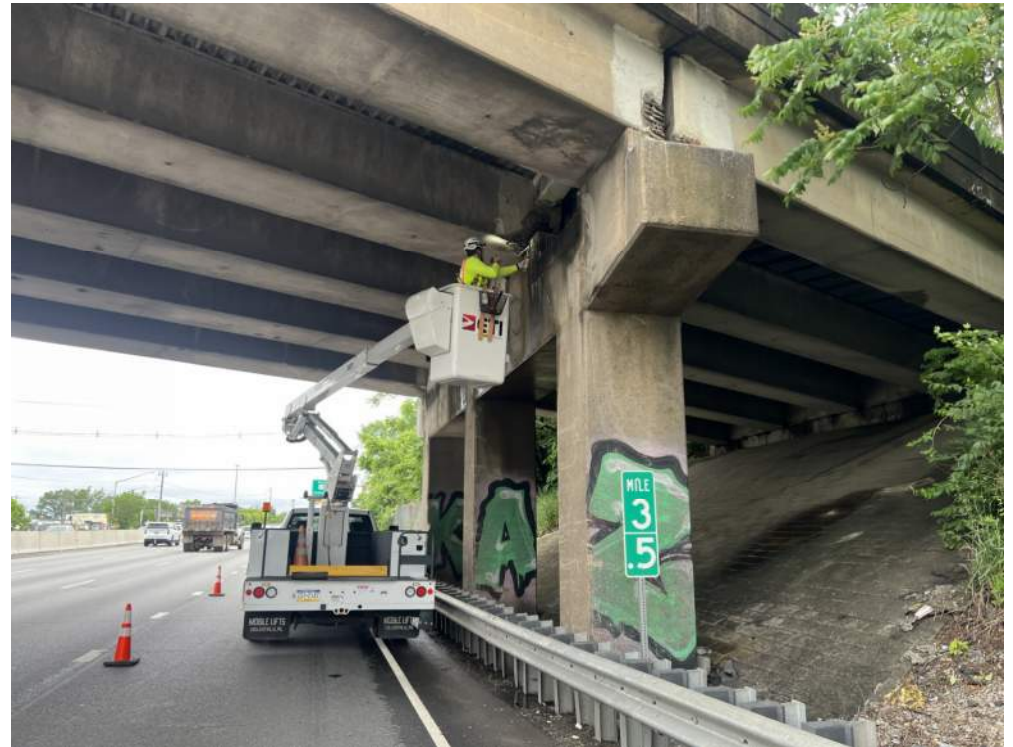
- Bucket Truck or Boom Lift

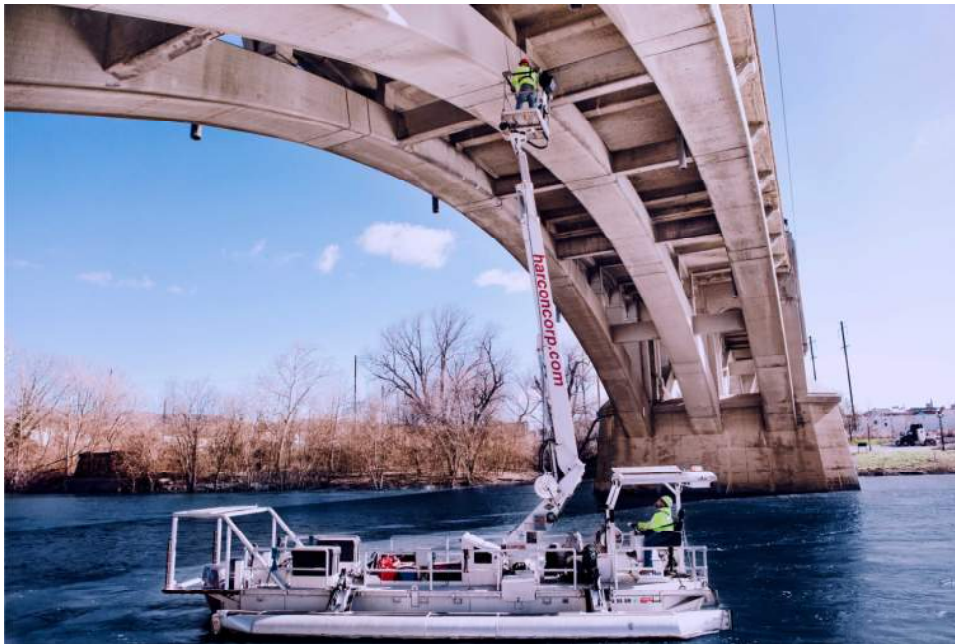
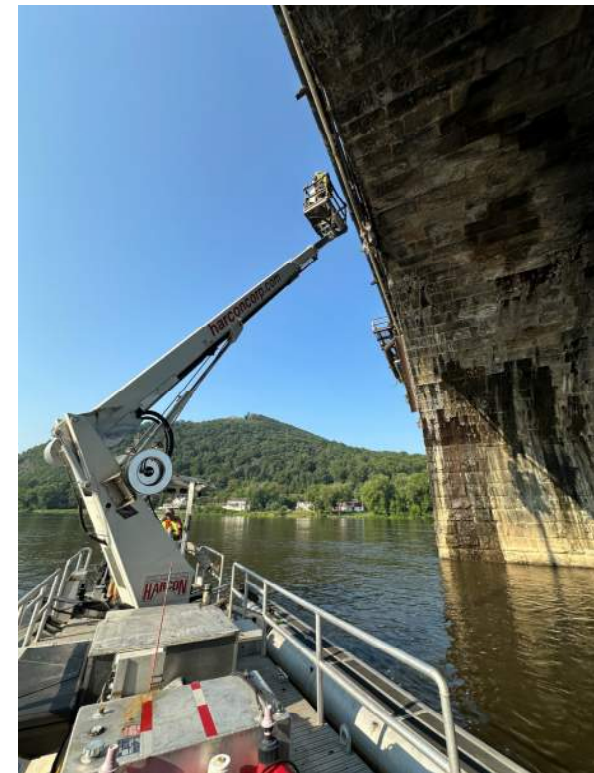
- Boat or Bucket Boat

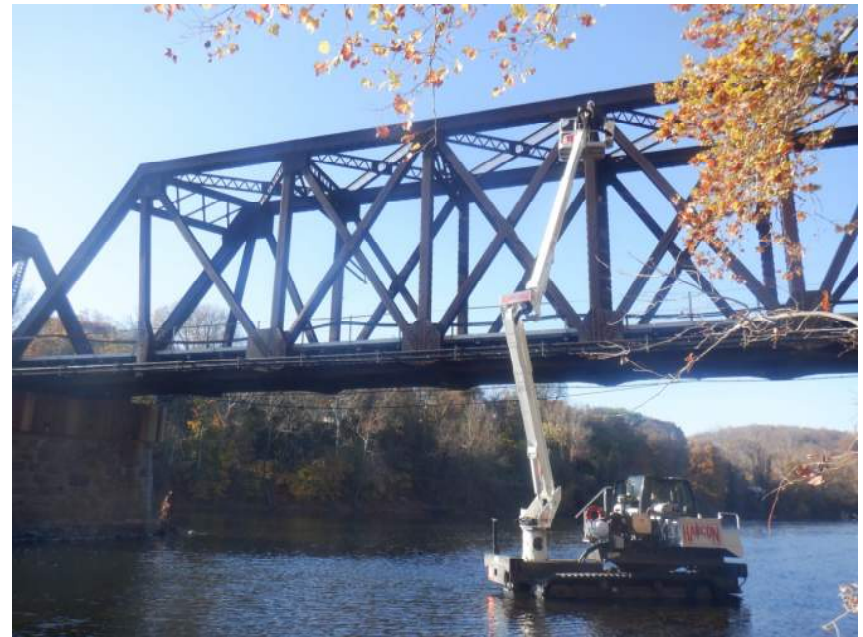
- Tracker

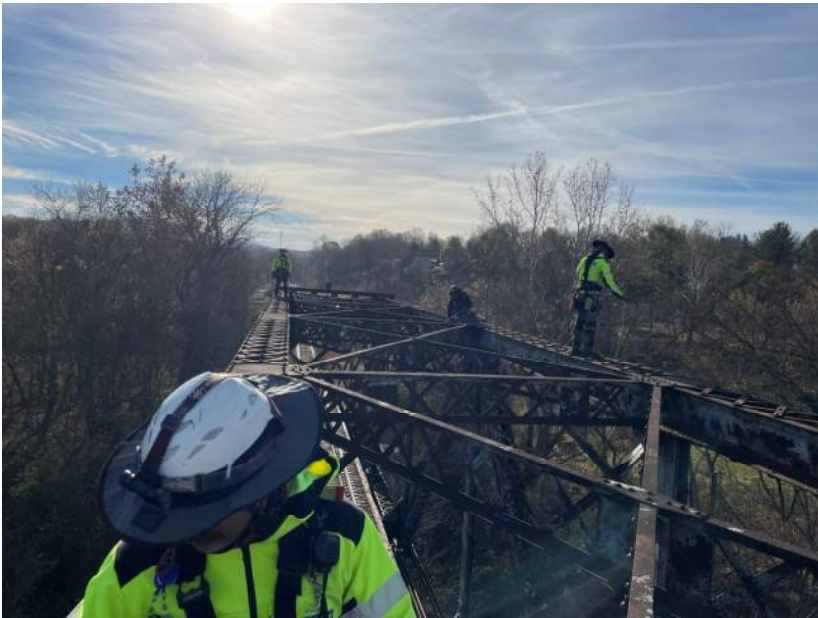
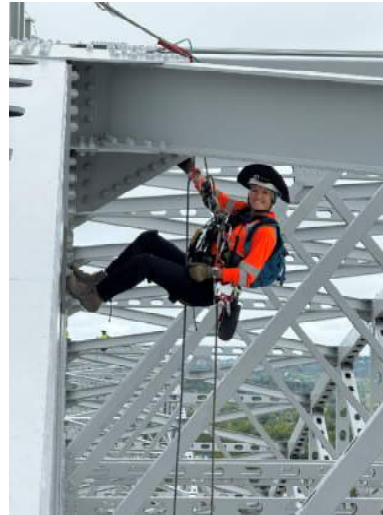
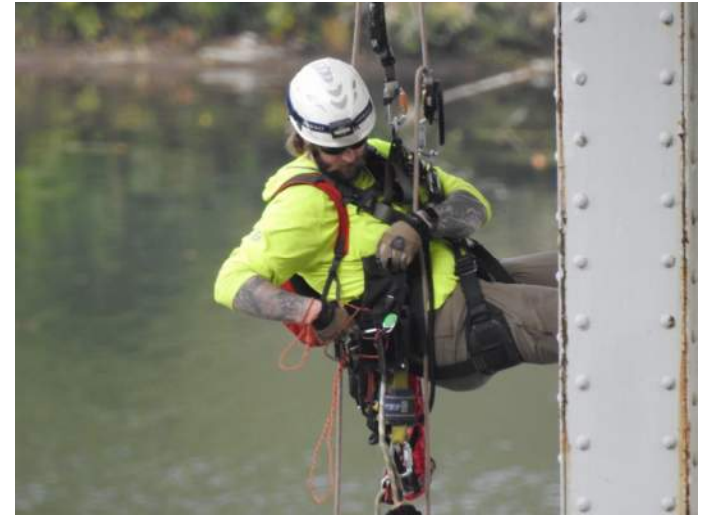
- Rope Access (SPRAT)

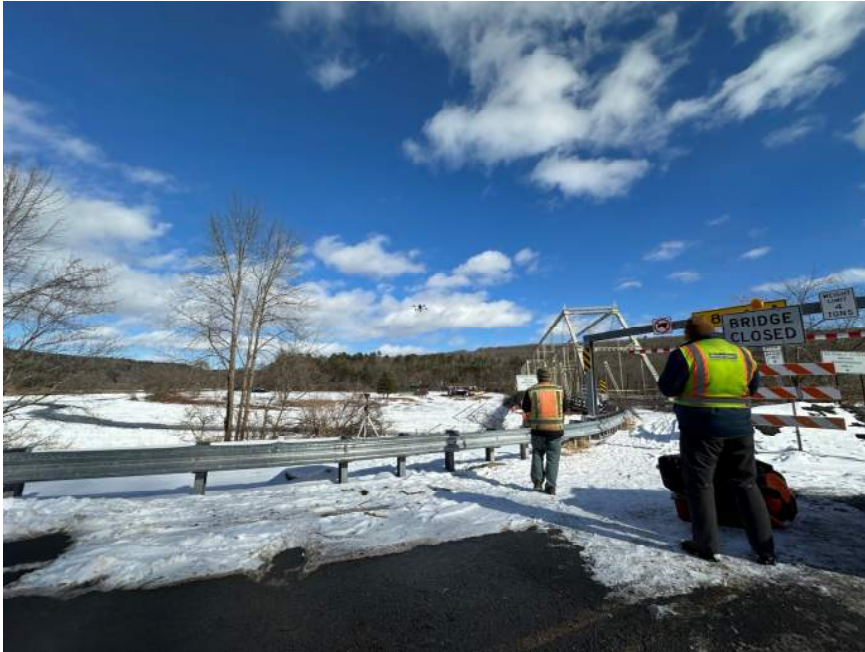
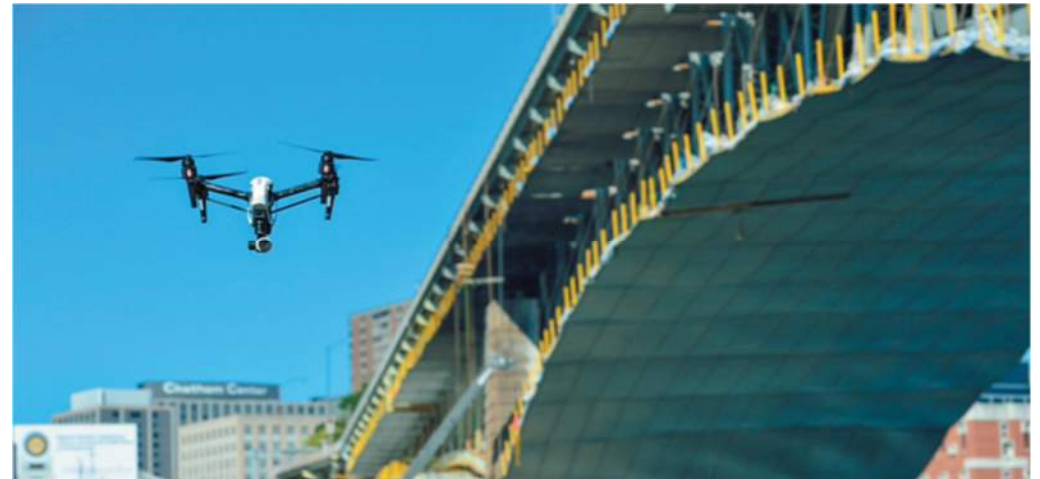
- UAS (Drones)
